! Rechts angeschlagene Tür  
Righthanded door  
Porte avec charnières à droit

## Rondo 2

Links angeschlagene Tür  
Lefthanded door  
Porte battante à gauche

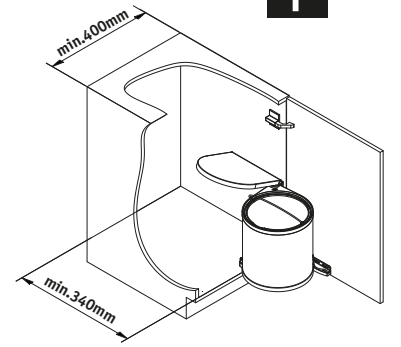
| Artikel | Liter | B | h1 | H |
| 8011005 | 13L | 280mm | 349mm | 359mm |

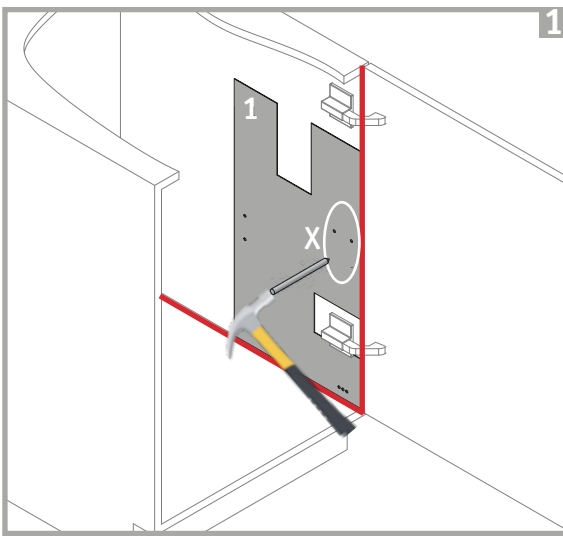
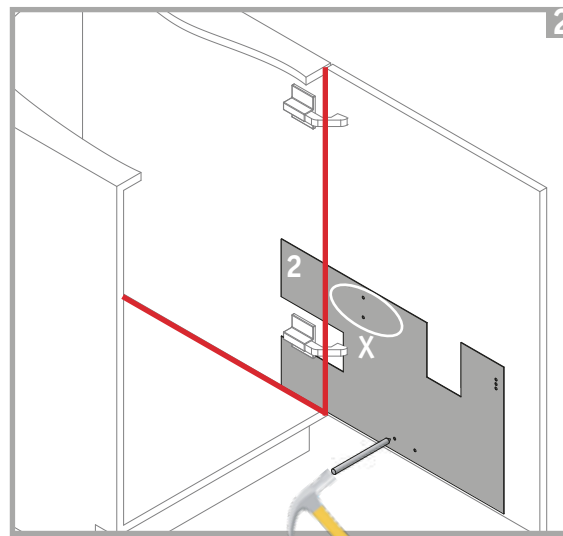
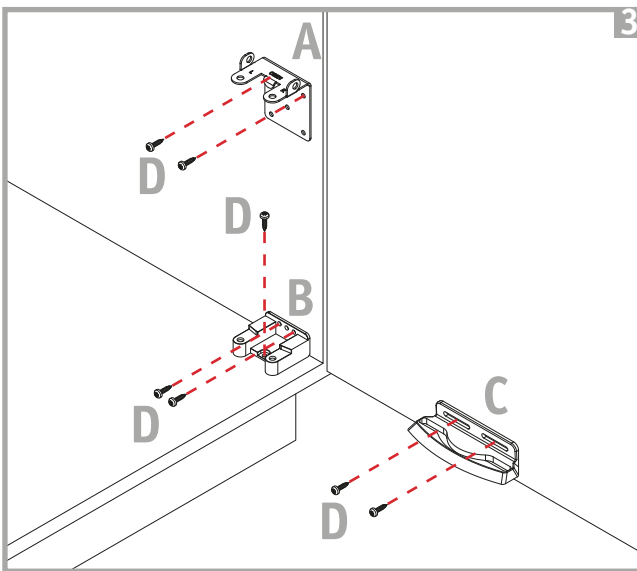
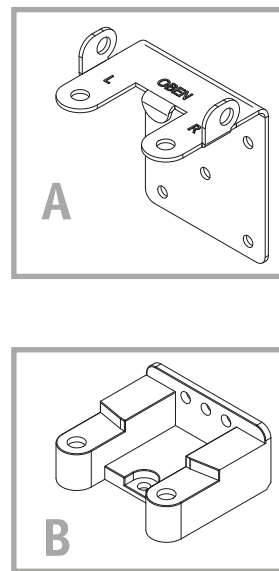
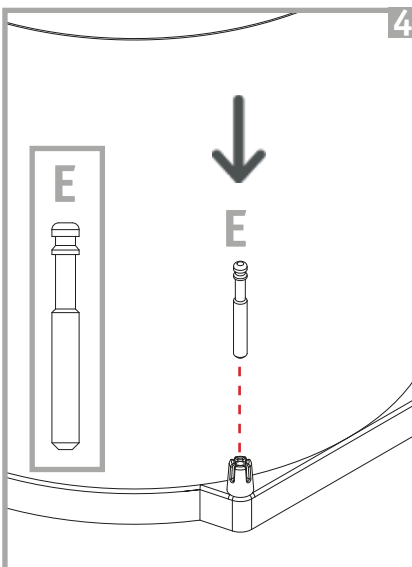
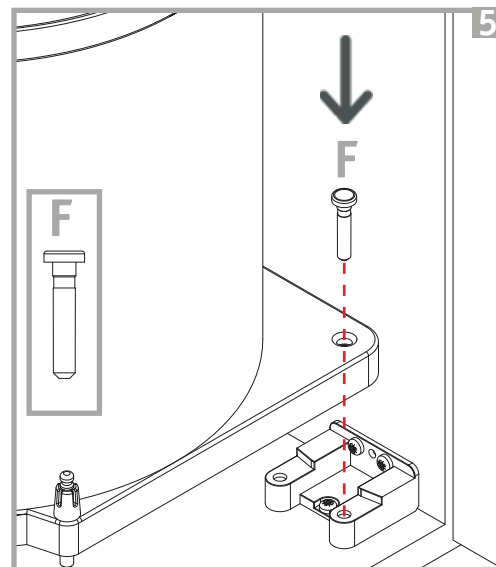
Schrankboden  
Cabinet base shelf  
Fond de l'armoire

Hinterkante Tür  
Rear edge, door  
Arete arriere de la porte

330mm

Vorderkante rechts Seitenwand  
front edge, right side panel  
arête avant a droite panneau de côté

165mm

47,5mm

19mm

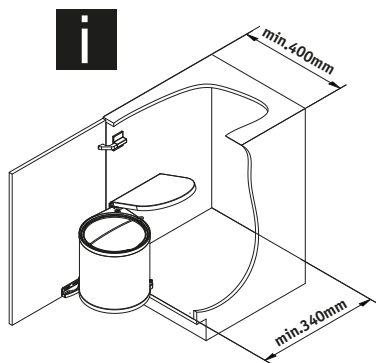
| Artikel | Liter | B | h1 | H |
| 8011005 | 13L | 280mm | 349mm | 359mm |

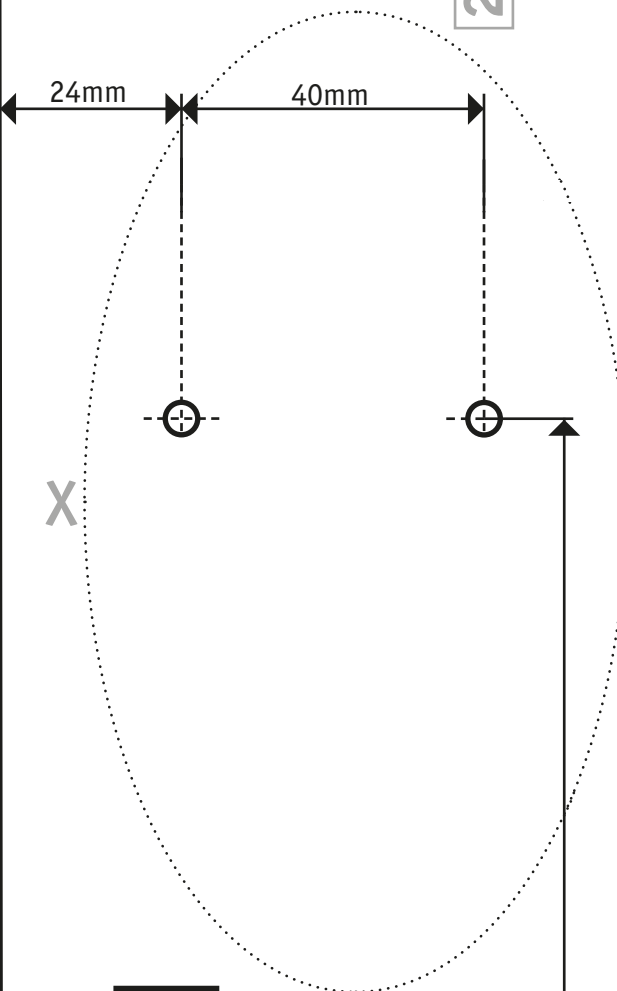
Schrankboden  
Cabinet base shelf  
Fond de l'armoire

Hinterkante Tür  
Rear edge, door  
Arete arriere de la porte

165mm

47,5mm

19mm
