# Test report

Client: Hermann Fedra/hda Contractor: Brita  
Pyttel/fbmk, hda

Order regarding: Tensile tests on additively manufactured plastic components

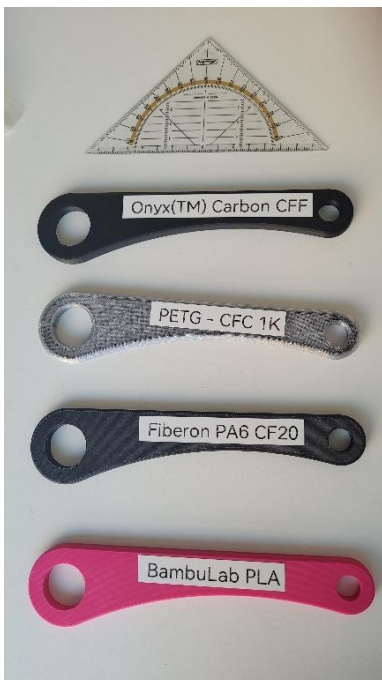
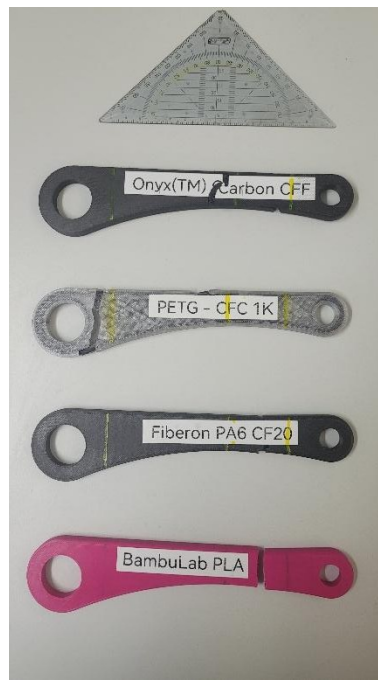
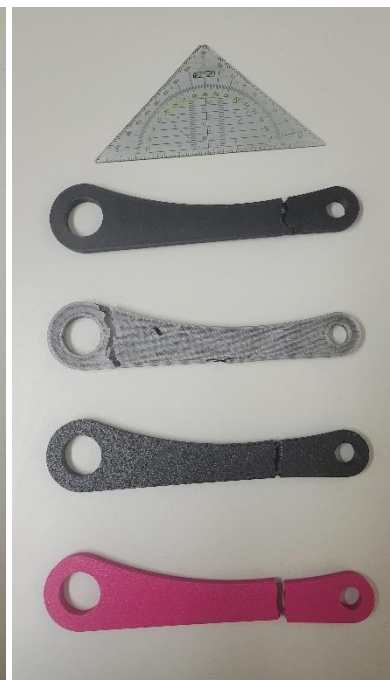
**Figure 2:** Plastic components in their initial state (left) and after the tensile test, front and rear (center, right)

A sketch of the plastic components delivered is shown in **Figure 1** on the left. The width at the thinnest point is approx. 22.4 mm and is marked with the middle yellow stripe, **Figure 2** center.

The installation condition of the components in the Z250 test machine is shown in **Figure 1** on the right. The components were clamped 50 mm from the bottom and 40 mm from the top, **Figure 1** on the left and yellow outer markings in **Figure 2** in the middle.

The force-crosshead travel diagrams are shown in **Figure 3**, and the maximum force and fracture mode are shown in **Table 1**. **Figure 2** shows the plastic components after testing, with the front and rear sides compared to their initial state.
